COVER PAGE

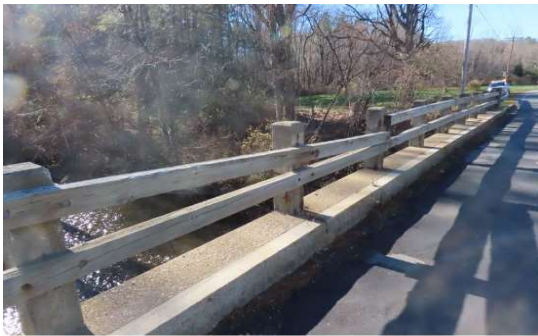
Photo 5: South railing with detached rails.

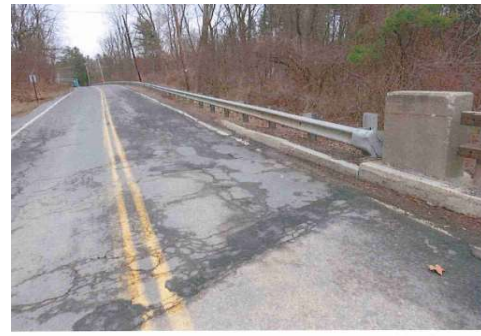
Photo 3: East approach with extensive cracking and areas of settlement.

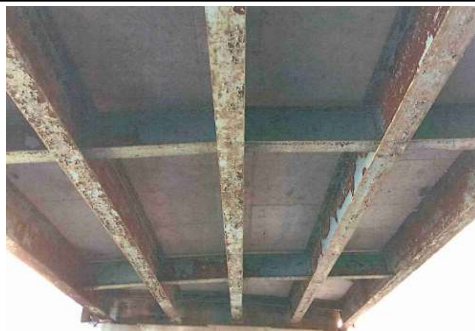
PHOTO 5 - TYPICAL FRAMING

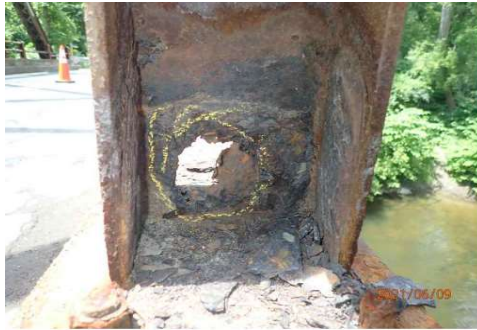
12: North Railing, 11th post from East Abutment with perforation in low web

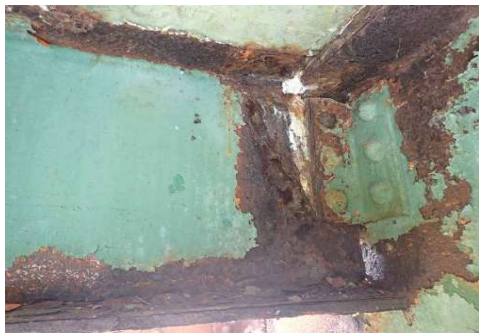
21: Stringer S5 at Floorbeam FB3, north face with rust and section loss

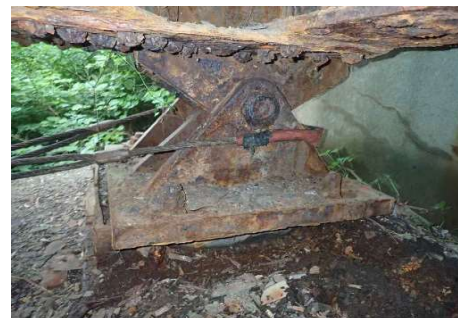
42: Southwest Bearing with debris, rust, and anchor bolt nut section loss as well as overexpansion with bent anchor rods

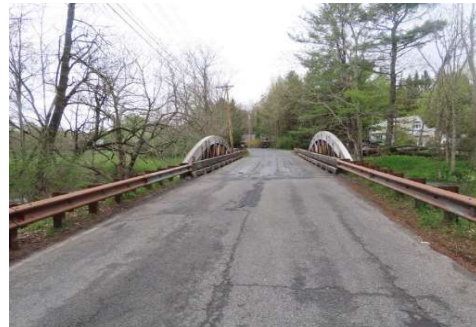
1: General topside, looking north.

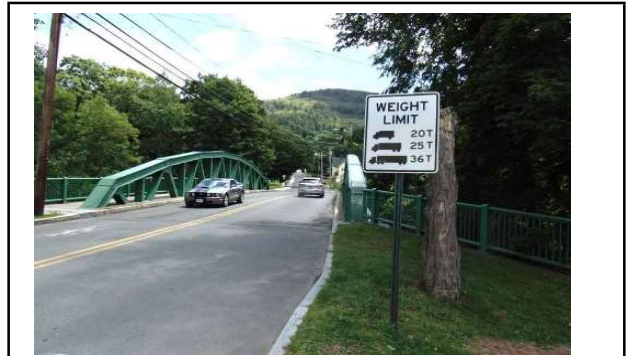
Condition Rating	Deficiency Rating
Sidewalks	- 5	M-P
Railing	- 5	S-P
Trusses - General	- 5	M-P
Bearings	- 5	M-P
Conn. Plates/Gussets	- 5	M-P

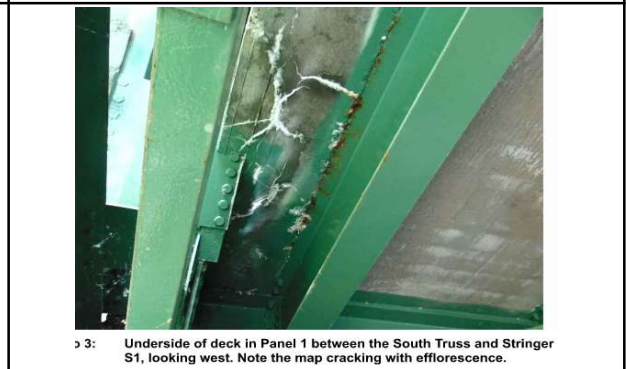
3: Underside of deck in Panel 1 between the South Truss and Stringer S1, looking west. Note the map cracking with efflorescence.

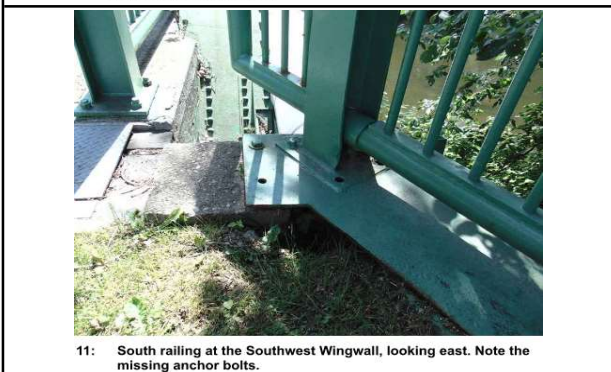
11: South railing at the Southwest Wingwall, looking east. Note the missing anchor bolts.

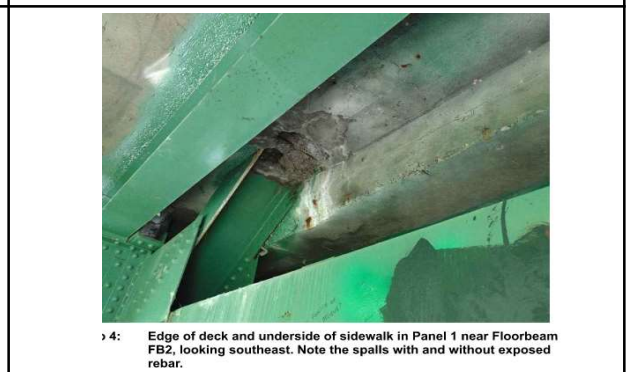
4: Edge of deck and underside of sidewalk in Panel 1 near Floorbeam FB2, looking southeast. Note the spalls with and without exposed rebar.

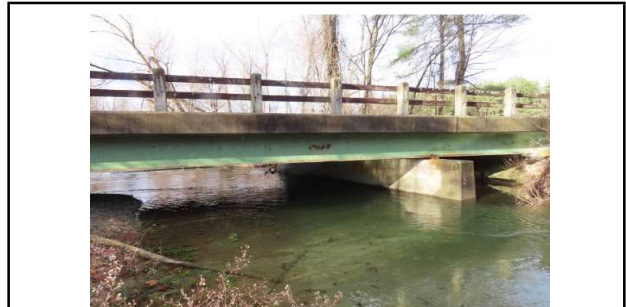
6: East elevation of spans 2 & 3 showing aggradation along pier 1 and main flow along Pier 2 resulting in a scour hole at the downstream nose.

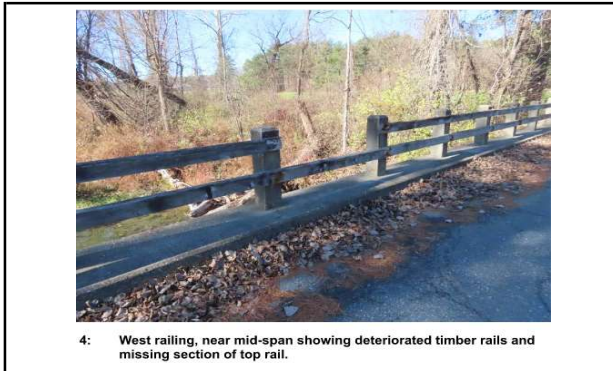
4: West railing, near mid-span showing deteriorated timber rails and missing section of top rail.

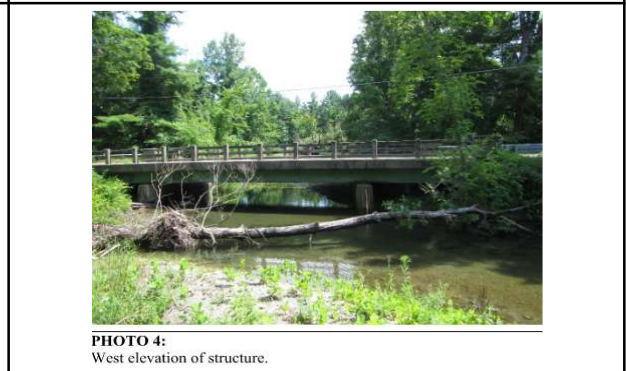
PHOTO 4: West elevation of structure.

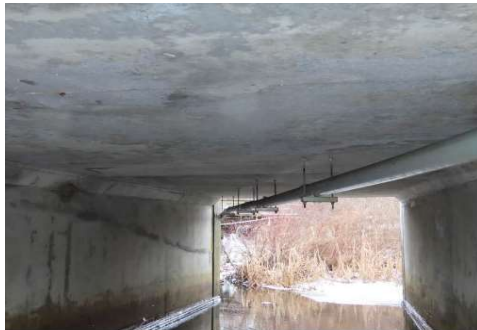
2: General underside, looking east.

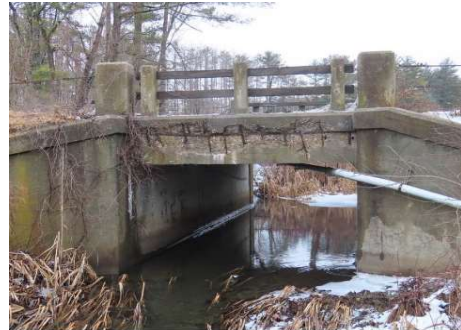
: Spalling throughout the west fascia (rail base and frame roof).

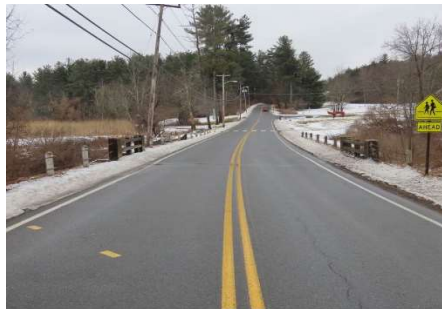
1: General topside, looking south. Note the west approach guardrail.

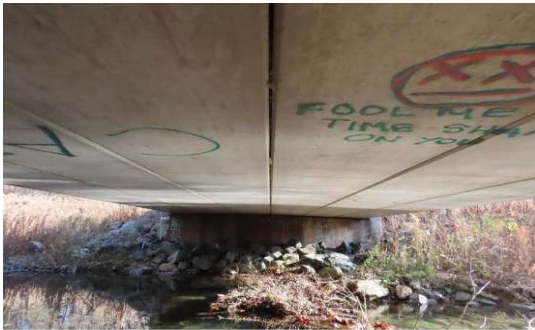
Photo 2: Typical underside, looking east.

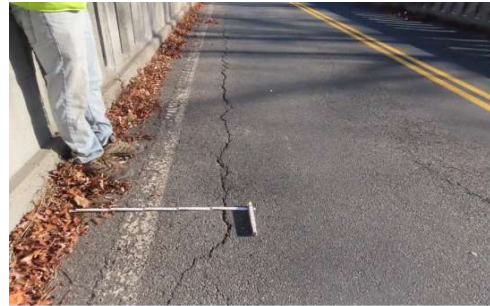
Photo 3: Longitudinal reflective cracking along the north curb, consistent with the misalignment between beams 1 & 2. Also, note the debris along the curbs.

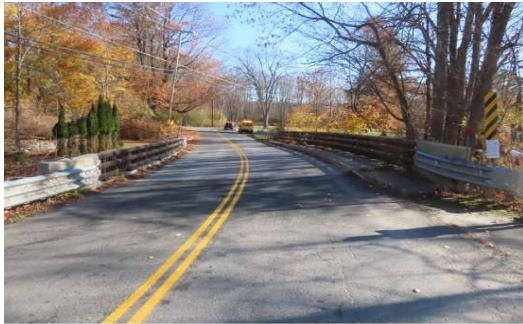
Photo 1: General topside, looking east.

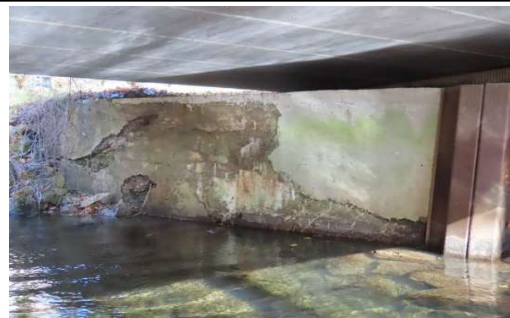
Photo 6: Old abutment wall at the east side showing extensive cracking, efflorescence and scaling.

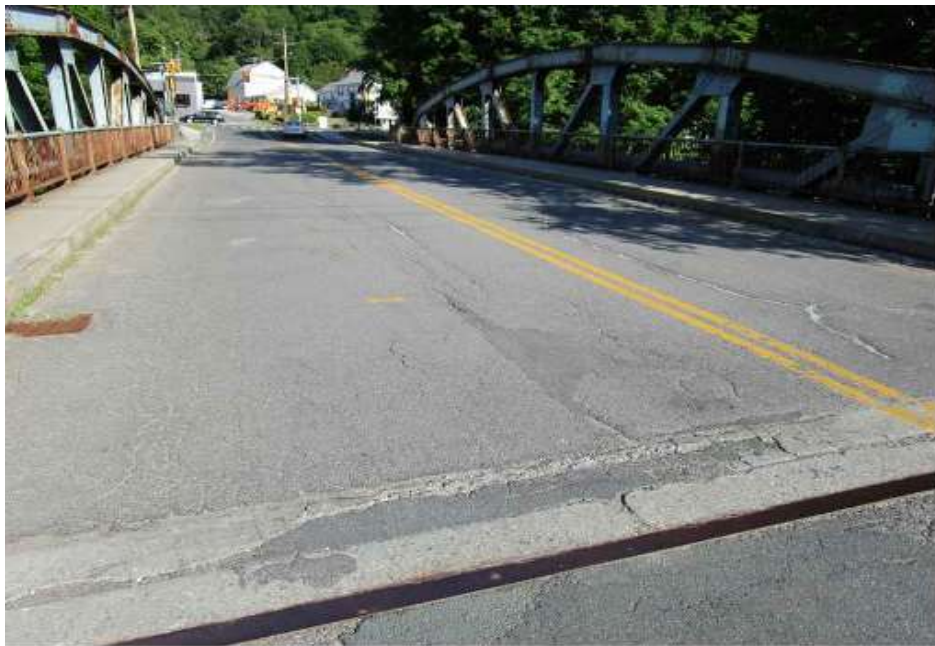
3: Typical Wearing Surface, Heavy Alligator and Longitudinal Cracking and Patches, Looking East
